Rolls-Royce Owners' Club of Australia Library

The Reconstruction of 42G7

by Nigel Steele Scott, 1989

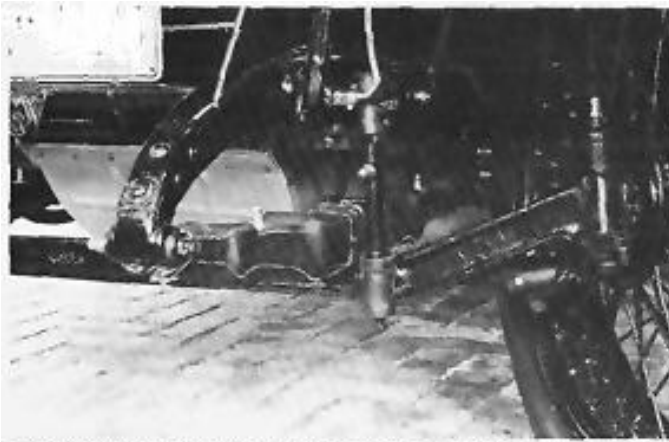
Front suspension showing Wefco gaiters, no brakes, a multitude of Enotts nipples, friction shock absorbers and the fitted undertray.

New spring gaiters were obtained from Wefco the original suppliers. I also had the numerous odd holes in the chassis welded up and repaired and refitted a set of correct shock absorbers to replace the odd collection that had been fitted over the years. The undertray was torn and part missing but I was able to construct a new one including the side plates and overcentre locks. The juxtaposition of copper and aluminium in this structure is a no-no and I can only assume it is an electrochemical joke of Royce's! While the undertray is easy to fit to the chassis in the absence of engine and body, every nasty thing written about it is true once the car is assembled. It was also necessary to turn up large numbers of square headed bolts as most seemed to have been lost.

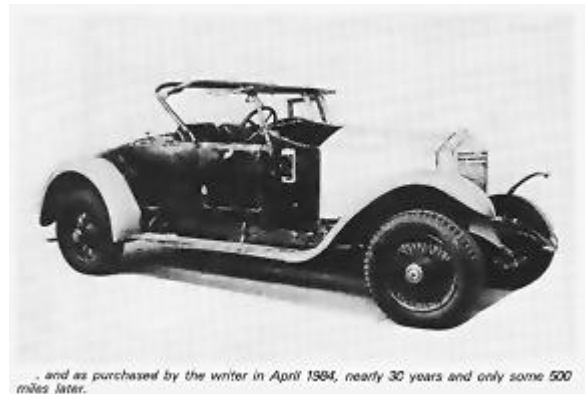
... and as purchased by the writer in April 1984, nearly 30 years and only some 500 miles later.

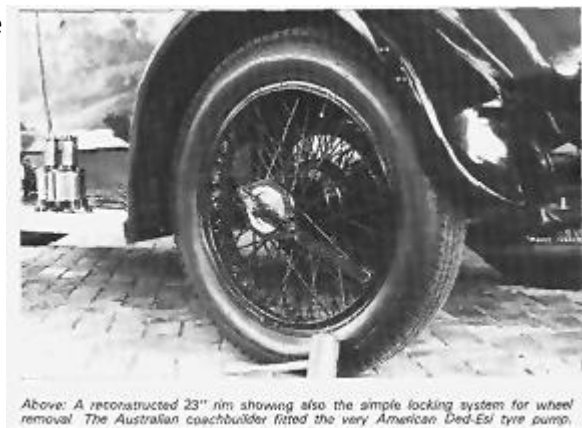
Above: A reconstructed 23" rim showing also the simple locking system for wheel removal. The Australian coachbuilder fitted the very American Ded-Esi tyre pump.

The wheels of the car had been cut down at some time to 119" wellbase and the car looked very unbalanced. After a lot of agonizing over costs I decided to put it back on 23" split rims. New rims available from the U.S.A. were too expensive. I also investigated making new wheels and although I think these early Twenties look much better balanced on the spidery wheels, I could not raise enough orders to make it worthwhile. I collected a set of four 23" spoked and four-disc wheels. After removing the spokes and discs new centre sections were welded into one spoked rim and two very rusty rims from the disced wheel set by the local wheelwright. The other 2 disced rims were useable as was. He then dimpled, drilled and spoked these rebuilt rims to my hubs with the correct butted spokes obtained from Central Wheel Components in Birmingham. Again, heat was needed, this time to straighten the split rings and these were fitted with rim locks as originally specified. Anyone who has spent time looking in the roadside bush for a split ring following a puncture would really value these. The wheels were then powder coated instead of enamelled. This has been very successful. Not only is the finish excellent, but the slightly plasticised feel of the finish has made the tyres and split rims much easier to fit and remove than from enamelled wheels. I have not chipped the paint despite numerous tyre removals which were necessary to finally get these rebuilt wheels round. As an aside one of the minor mysteries of life is how to remove the Dunlop hub nuts from the wheels - easy when you know how. Tyres and tubes (5.00 x 23) come from Australia's own (via Taiwan) Beaded Edge Tyre Co. of Newcastle, NSW.

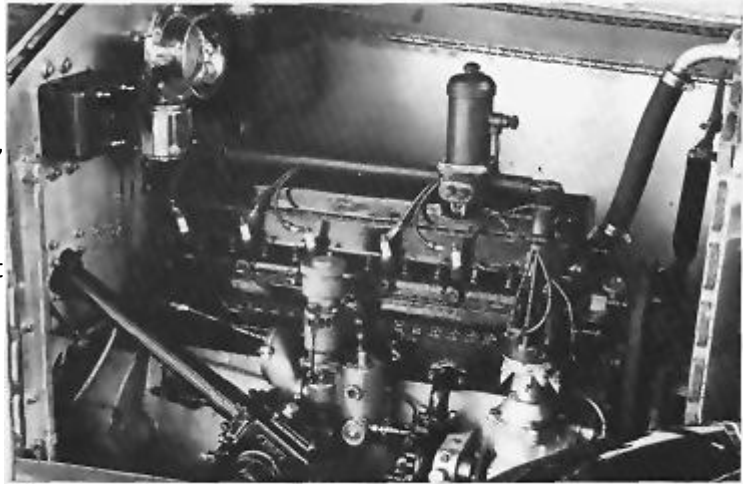
Off-side of engine. The offset of the major part of the cylinder head casting allows spark plug insertion closer to the crown of the combustion chamber and the valves. There is a bewildering array of control rods and levers.
