Rolls-Royce Owners' Club of Australia Library

A Pre and Post Rally "Dawn Patrol"

by Lloyd Missen (NSW), 1998

Part Four

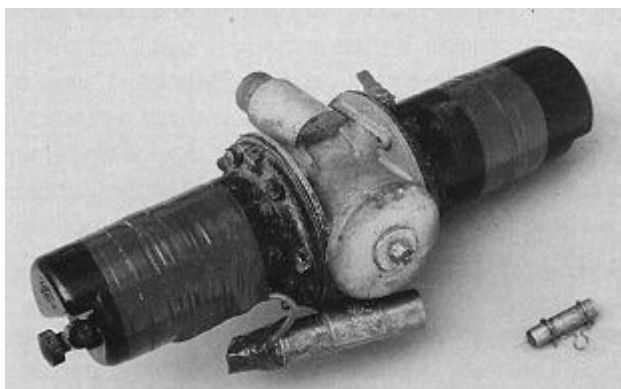
At last! I thought. I knew immediately I had found the problem. To confirm I re-connected the capacitor and the diaphragm remained pulled in, then disconnected the capacitor and diaphragm oscillated proving that the capacitor at this moment was obviously short circuited, which I then confirmed with a meter. Thus, the stalling all this time was caused by a fault in this tiny capacitor and the difficulty in finding it was that *the fault in the capacitor was intermittent*.

My guess is that the fault varied between open-circuit and short-circuit. When open-circuited the arc quenching properties of the capacitor was not there, resulting in burning of the contacts I had noticed but could not understand.

When short-circuited the pump coil remained continually energised with the diaphragm pulled in. The pump coil is not designed to be continuously energised, so it overheated. The other pump was called on to deliver the fuel needed so it was over-working thus its coil was also operating above normal temperature. This together with the 40°C air temperatures we were experiencing caused vapour to develop in the small valve chamber between the two pump bodies. The build-up of vapour eventually reached the point when the one good pump was unable to deliver fuel and *Helga* stalled. This only occurred when the intermittent fault in the capacitor was in the shorted state, and initially the heat build-up was only sufficient when *Helga* had stopped after a long run.

The tiny capacitor with the intermittent short, the cause of so much trouble, shown in front of *Helga's* pump with the spare distributor capacitor, as a temporary replacement, strapped to the outside.

Delighted that I had found the problem I walked around to 'the mechanic', held up the faulty component and asked if he had a capacitor, any size would do. His reply, "*I wouldn't have anything like that*", surprised me, but undisturbed I returned to *Helga*. I knew I could get home without such, the points would just continue to burn but most likely still function. Then I remembered, Rolls Royce being what they are, there was a spare capacitor mounted on the distributor body. It was much larger and would have to be mounted outside the pump's phenolic end cover but that presented no problem.

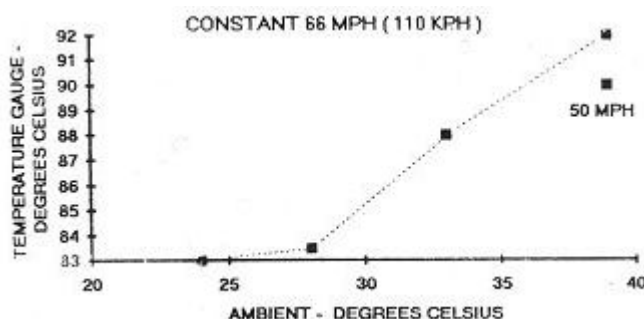
Graph showing increase in the Dawn's Temperature Gauge reading under constant load (i.e. constant speed, level road) with increasing ambient temperature.

The results show that as the ambient rose above 28°C the coolant temperature rose quite rapidly and almost linearly. On the days when we experienced the very high ambient it was

necessary to drop the speed to limit the coolant temperature. Similarly, when hills were encountered, although rare on this run, the coolant temperature rose, and dramatically so in high ambients. So the new core had not solved *Helga's* overheating problem, and its solution still remains a challenge.

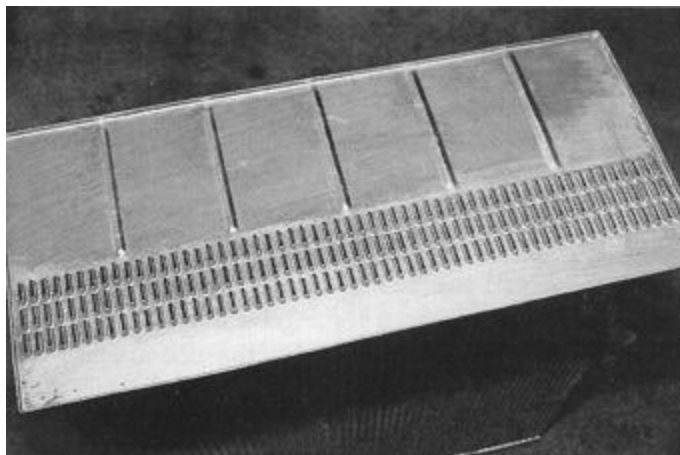
I was surprised that the new radiator had not resulted in an improvement on this Overlander. NATRA, the manufacture, was equally surprised and after removing the header tank and confirming the tubes had remained clean and unblocked, they supplied another core at their expense. This has a larger number of tubes (171) of greater cross section (2x15 mm) and improved finning. (See Photo and compare with the 'Overlander Core' in [Part 1](#)). Preliminary tests with this latest core indicate that the problem still exists.

View of the top plate, before mounting the header tank, of the radiator core supplied by Natra after the Overlander, with more tubes each of greater cross section. Compare with Part 1.

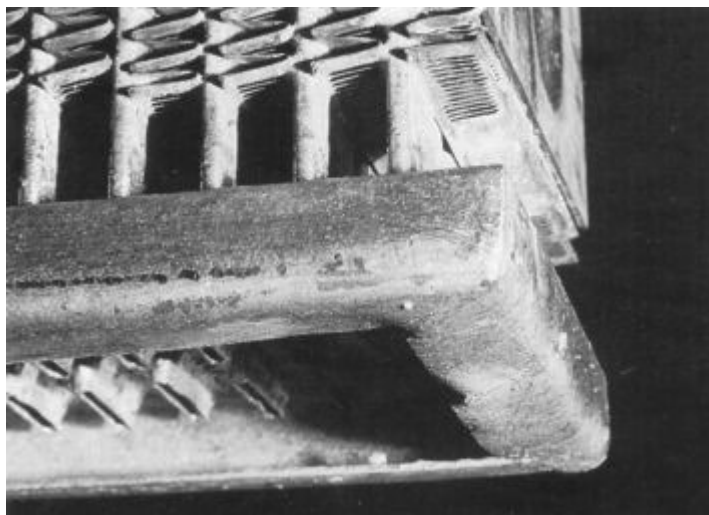
Close up of the bottom plate of the latest Natra Core. More efficient zig zag as opposed to laminar finning has been used, together with serrations to maximise heat transfer to the air stream.
