Across the Nullarbor in Silver Dawn SFC138 "Helga"

By Lloyd Missen, 1998

Pre-Overlander Preparations

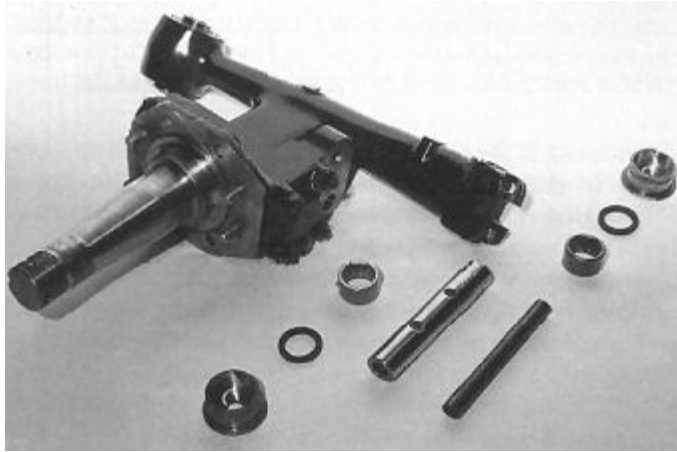
Ever since we had owned the Dawn excessive play existed in the steering. Obviously, now it was time to bite the bullet, degrease the front end and carry out a thorough examination to see what really needed to be done. It wasn't quite as bad as it could have been. The inner steel bush in the Silentbloc bearing in the upper end of the yoke had separated from the rubber, both lower yolk bearings were "shot" requiring new bearing pins, roller housings and rollers and the steering box needed adjustment. Fortunately, the pivot axle was quite sound. The chassis lubrication system had maintained oil supply to both top and bottom pivot bearings, no water had entered and a maximum up/down deflection of only 0.003" was evident at the outer end of each stub axle. This was a relief as replacement would have been expensive and time consuming. New Silentbloc bearings were installed but were really tight and required a long lever and my full weight on my 2.25 tonne Kmart jack to extract the old ones and then press the new ones home. Not a simple "screw thread exercise" as per manual.

A cleaned-up stub axle assembly with a new Silentbloc bush pressed into the yoke. Shown are the new needle bearings complete with outer journals, original housings bored out to suit, neoprene quad seals, manufactured bearing pin and internal spacer. Washers, not shown, were made to provide the right cavity for the quad seals.

Replacement of the lower yoke bearings was not expensive with the method adopted but required a few hours machining on the lathe; ASSAB Steel (Auburn/Brookvale) provided AIR 4140 steel blanks and a nitriding service after machining. Thus, new bearing pins to original Rockwell hardness figures were produced for a few dollars. Consolidated Bearing Co. (Artarmon) came good once again with suitable components this time with roller bearings complete with outer journals and it was only necessary to bore out the old worn housings to suit- One eight-inch square neoprene 'quad' seals were installed in lieu of original felt seals and should provide better oil retention and water exclusion. With steering box adjusted the Dawn felt like a new car.

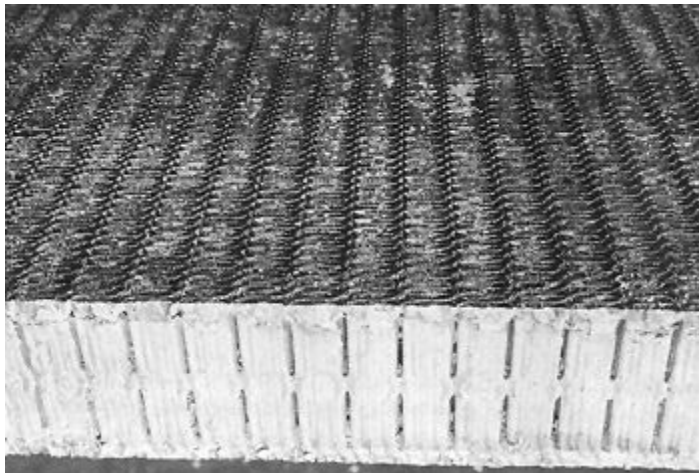
Prior to reinstalling the radiator, I took it to a large North Shore Repairer to have the top tank removed to determine whether there were tube blockages; however, I was forced to accept a 'reverse flush', an acid dip and a second 'reverse flush'. The radiator was of so-called 'cellular' design, manufactured in New Zealand where the finning and two rows of tubes, front to back, were formed from an assembly of brass zig-zag strips of quite complex shape, crimped and soldered together. With this design and from previous experience, the Repairer was simply not game to unsweat the top or bottom tanks, for fear of ending up with a series of leaks he was unable to seal. Hence, ever since, I have remained unsure of the state of the radiator.

View of the old "cellular" radiator core, unsweated from the top tank, showing some blockage evident in the two rows of tubes, which are formed from an assembly of crimped and soldered zig zag brass strips of quite complex shape.

With the distance contemplated to Fremantle and return, the high continuous speed and the very high ambient temperatures likely, it was essential that I knew the state of the radiator before we set out. I therefore visited another Repairer and explained the situation. His reaction was much the same and recommended fitting a new radiator of more conventional design, which I eventually agreed to. The new core consisted of 148 vertical tubes of 2 by 11.5 mm cross section set in four staggered rows front to back with horizontal finning. Natra, the Radiator Manufacturer, prepared the core with the top and bottom plates soldered to the tubes and it was only necessary for the Repairer to solder on the top and bottom tanks and insert the radiator into its frame. I had the radiator back in the Dawn just under 24 hours before departure. Unfortunately, due to time, a run up the hill from Roseville Bridge was its only pre-Overlander trial!

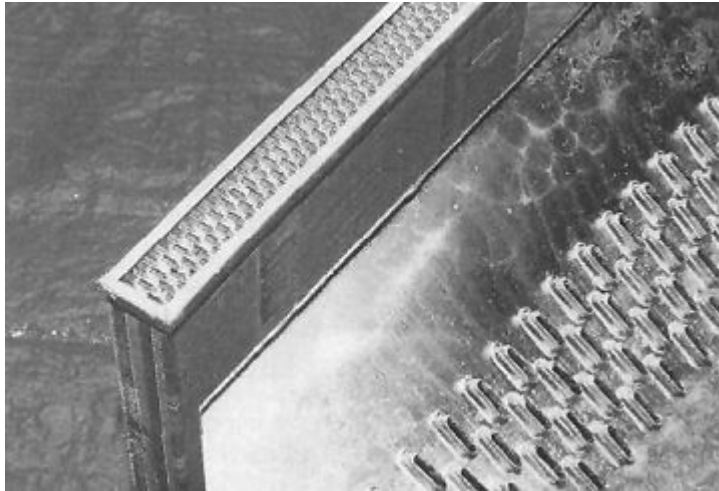
The new core as supplied by Natra complete with top and bottom plates ready for the Repairer to solder on the original tanks (Bottom plate uppermost), The insert shows the four rows of tubes protruding through top plate.
