Rolls-Royce Owners' Club of Australia Library

Increasing Air Intake on Early Post-War Cars

By Tony Ward (NSW), July 1999

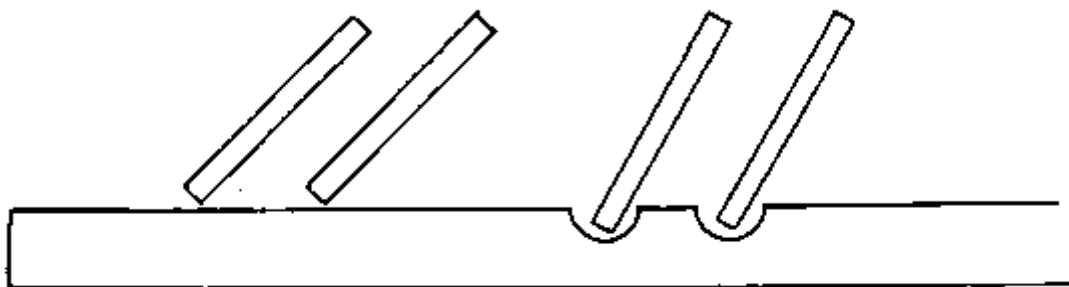
Figure 1. Left, the original position of the louvres. Right, new position with notches filed in the bar.

- *The notch cut in the bar to give the louvres clearance*

- The louvres are held top and bottom by two rows of 1/8" pop rivets.
- With a 1/8" drill, carefully drill out the front row of rivets top and bottom.
- Using the rear rivets as a pivot, open up the angle of separation to 1/2" using a drill shank as a spacer.
- I found that the centre holding bar of the louvres needed a small notch cut into it where every louvre touched hard against it in the new open position. (Figure 1). Use a triangular file or the side of a drill bit (hardly kosher!). This notch relieved any tension on the louvre because of the new top and bottom positions.

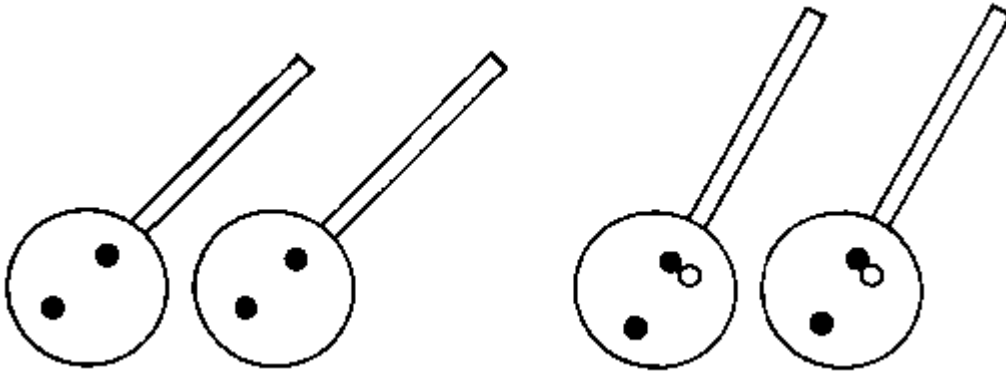
Figure 2. Left, louvres in their original position. Right, new hole drilled to accommodate new angle.

- With the louvre held in its new position, drill a new hole through the frame and base (and top) of each louvre so that you can drill and pop rivet and thus re-position it. (Figure 2). Use 1/8" drill and rivets.

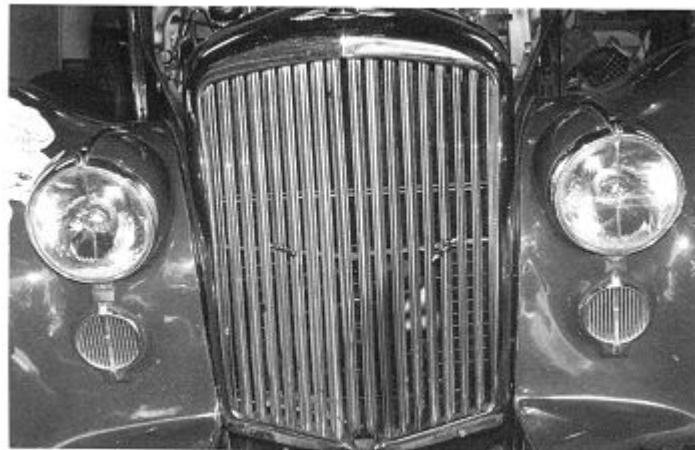
As you can see by the frontal photo, where the righthand side has been opened up, but not the left, there is very little loss of aesthetic appeal. There is a 5/16" drill in the unaltered half and 1/2" in the opened sections. When one stands off and looks at the radiator grille, most people are unaware that there has been an alteration.

Frontal view - right side altered, left side standard
