A Pre and Post Rally - "Dawn Patrol"

by Lloyd Missen (NSW), 1998

Part Three

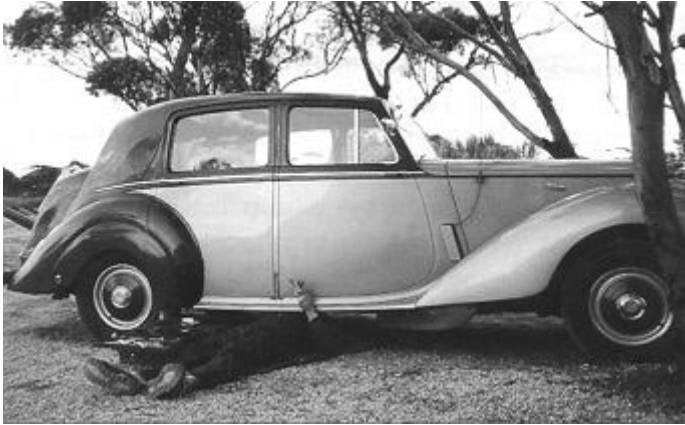
The petrol pumps are easily removed from under the chassis. To prevent emptying the fuel tank onto yourself, the siphon must be broken by removing the fuel filter cover.

We were now in a pretty desolate part of the country and keen to avoid roadside repairs away from civilization I removed the petrol pumps on the grass outside the Motel for test and inspection before we set off. Both sides ran perfectly but the points were more pitted than expected, as I had refurbished the pumps not all that long ago, including a satisfactory 500 volt DC megger test on each capacitor. The capacitors are across the points to assist the operation of the coil by accelerating the collapse of the magnetic field when the points open, and to minimise arcing and subsequent pitting at the faces of the points. I was therefore surprised at the degree of pitting. I cleaned both sets of points and both pumps worked perfectly before and after reinstallation in the car. We set off hoping to make Norseman that evening.

I felt that the toggle action may not have been set correctly and separated each diaphragm from its coil body and valve chamber. First unscrewing it completely from the contacts/toggle assembly so that it could be examined for holes then reinserting it and adjusting the toggle action for correct and positive 'throw over'. The procedure is to unscrew the diaphragm stem until the first toggle 'throw over', on pressing the diaphragm, then unscrew a further 2/3 of a turn before replacing the screws between coil body and valve chamber. After again refacing the contacts (points) and resetting the contact stops I applied 12 volts to each pump in turn. Back in the car and with the rubber fuel line disconnected and aiming at outer space, each side was capable of delivering a healthy stream of fuel out of the engine bay. Finally, coupled to the carburettor each side appeared healthy.

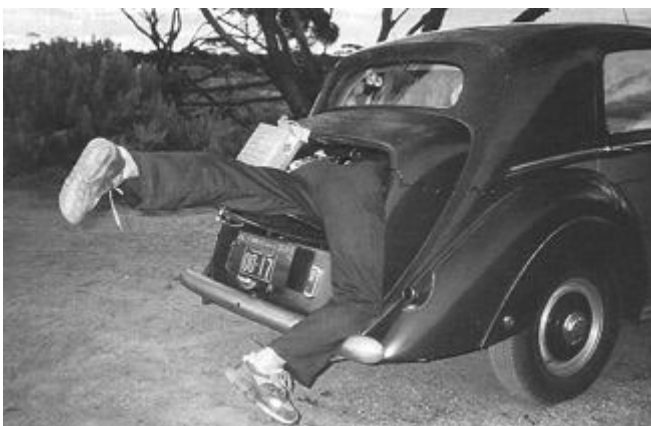
Access to the fuel filter is via two inspection plates at the rear of the boot secured to the boot and tyre compartment floors. A torch is needed.

I checked the delivery fuel filter accessed through the floor of the boot for blockage and also the short copper fuel lines either side of the pumps and was left somewhat nonplussed at what was actually going on. The only place for a vapour lock I reasoned, was the valve chamber between the two pumps. Temperatures had been in the high thirties, and I reasoned that vapour lock developed in this chamber only after we stopped because of lack of cooling air past the pumps with the car stationary, but with radiant heat from the very hot earth still present.
